Manhole Inspection Summary

Manhole # S53C__034MH

Insp Date: **6/12/08 10:01 AM**

Location Address: **32 n clinton st**

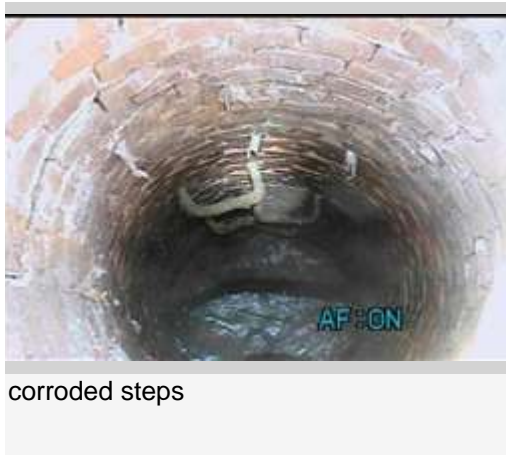
Defect 3

Steps Count: **7** Missing: **2** ☒ **Corroded**

corroded steps

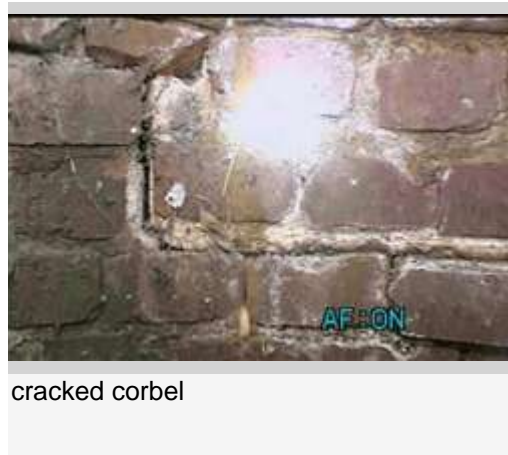
Defect 2

Condition: ☐ Sound ☒ **Cracked** ☐ Root Intrusion ☐ Loose Brick ☐ Deteriorated

cracked corbel

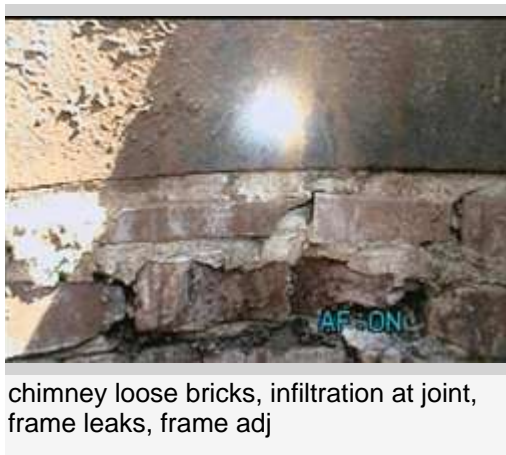
Defect 1

Frame Offset: **0** (in.) Condition: ☐ Sound ☐ Cracked ☒ **Leaks**

Condition: ☐ Sound ☐ Cracked ☐ Root Intrusion ☒ **Loose Brick** ☐ Deteriorated

Infiltration: ☐ None ☒ **Joint** ☐ Cracks ☐ Mortar ☐ Roots ☐ Wall

chimney loose bricks, infiltration at joint,
frame leaks, frame adj

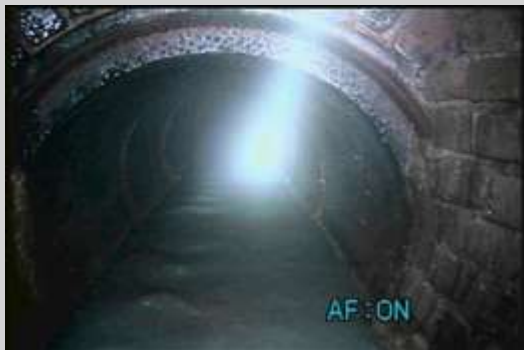
12 O'Clock Outflow

24 in. Circular Gravity Sewer
Pipe Out @ 12 O'Clock

Pipe Material: **Concrete** ☐ Pipe Lined

Invert Depth: **14.51** (ft.) Flow Characteristics: **Fast**

Infiltration: **None** Pipe Seal Cond: **Unknown**

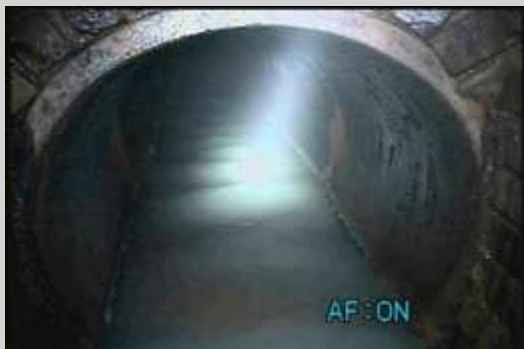
3 O'Clock Inflow

24 in. Circular Gravity Sewer
Pipe In @ 3 O'Clock

Pipe Material: **Clay** ☐ Pipe Lined

Invert Depth: **14.46** (ft.) Flow Characteristics: **Fast**

Infiltration: **None** Pipe Seal Cond: **Unknown**
